## Evidence of use of road drainage culverts by *Timon lepidus* (Daudin, 1802) in Western Andalusia

Use of road drainage structures and other potential underpasses such as culverts by reptiles is scarcely studied. We present photographic evidence of Ocellated lizards (*Timon lepidus*) using a narrow, linear road drainage under an intense-traffic road in western Andalusia (Seville). Our finding suggests that lizards could benefit of using these alternative routes diminishing risks of road killing, and that even narrow culverts could be contributing to an inter-habitat displacement in this threatened lizard species by mitigating habitat fragmentation effects.

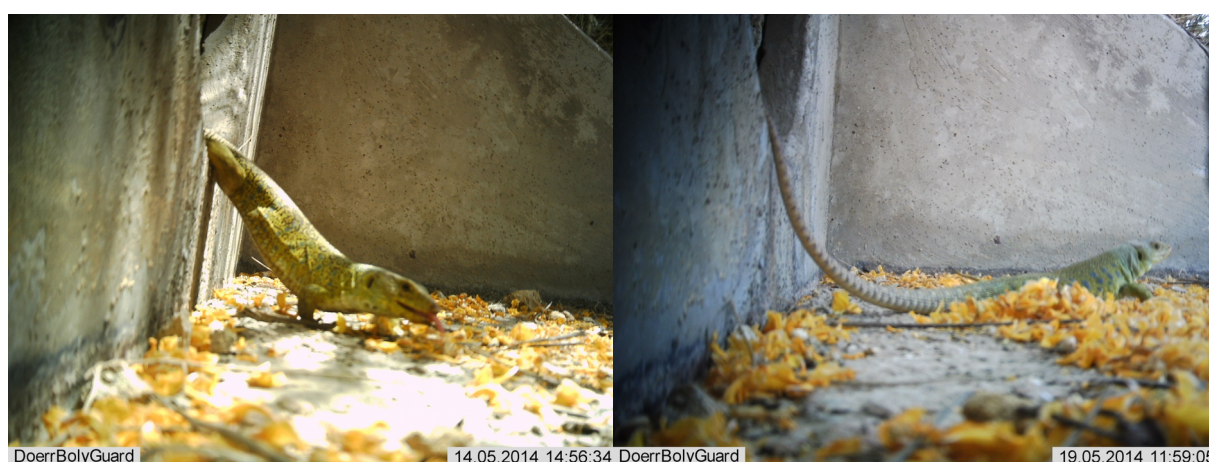
**Figura 1.** Capturas de cámara de dos adultos diferentes de lagarto ocellado en el paso inferior #4, segmento de carretera 1; A) arriba: individuo #1; 14/05/2014 (GMT: 14:56:34 h); B) abajo: individuo #2; 19/05/2014 (GMT: 11:59:05 h).

**Figure 1.** Camera captures of two different adults of Ocellated lizard at underpass # 4, road segment #1; A) above: individual #1; 14/05/2014 (GMT: 14:56:34 h); B) below: individual #2; 19/05/2014 (GMT: 11:59:05 h).

In underpass #4, 8 photos corresponded to rats (probably *Rattus rattus* L., 1758), clearly entering or emerging from the culvert; 1 to a House sparrow, *Passer domesticus* (L., 1758) at the entrance; and 5 photos showed presence of Ocellated lizard, two of them neatly emerging from the culvert mouth. The camera was stolen in subsequent days from another nearby location, and the photographic survey was thus interrupted.

The used culvert had the following traits: location UTM: 30S 246404 E, 41289 N; elevation: 65 m; type of section of the structure: circular; diameter: 60 cm; approximate length: 48 m; material: concrete; linear shape: straight; visibility: both mouths visibly open and unconcealed by deposits or rubbish; fitted with a central air vent (median of the road); presence of outer lateral ledges; vegetation cover within 5 m of mouth: 60%, composed of shrub and herbs; distance to asphalt road edge: 5 m; road edge located at a height from passage mouth level of ca. 3.5 m.
